**ANALYSIS OF OCCUPATIONAL RISKS IN THE ACTIVITIES OF
CARPENTRY AND LOCKSMITHING IN PAU DOS FERROS / RN: a
case study**

Keywords: Carpentry; Occupational risks; Environmental measurements

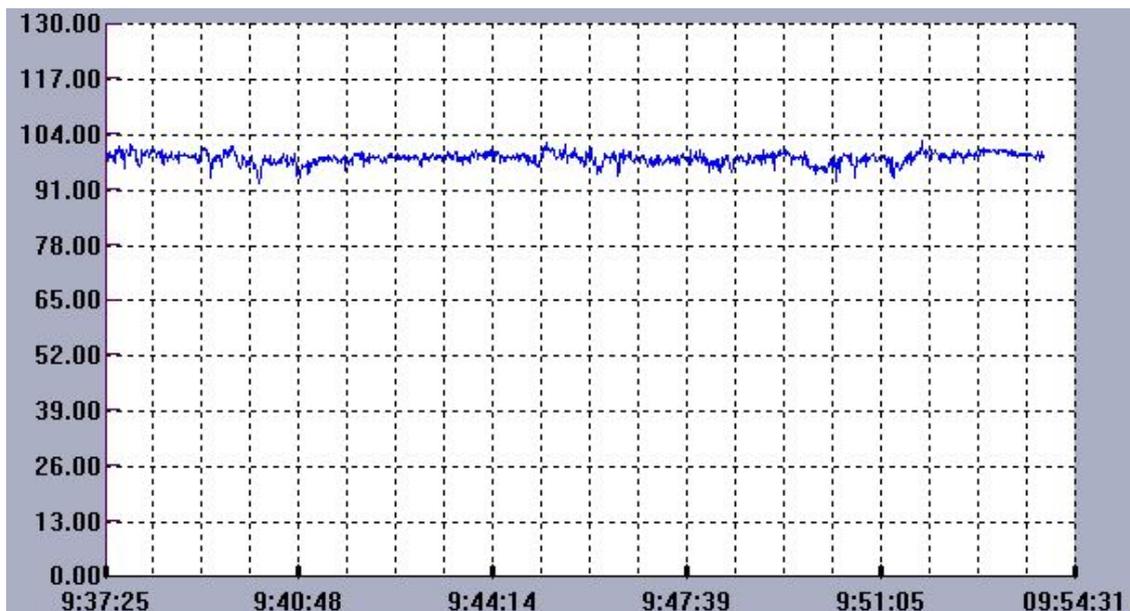
Figure 2: Graph of noise measurement

According to the measurements made, it is verified that noise production is presented as one of the most aggravating problems in the Carpentry where the study was conducted. In this sense, 994 measurements were taken and from these it was verified that the noise produced in the environment had a minimum value of 92.1 dBA and a maximum of 102.5 dBA. In addition, the mean of the measurements was 98.15 dBA and the most repeated value was 98.4 dBA. To calculate the sound pressure level in the environment, as reference it was followed the NR 15 and it was found that the noise produced was intermittent with a value of 98.8 dBA. Figure 2 shows the graph generated by the decibelmeter.

Comparing this value with the aspects of NR 15, it is evident that the production of noise in the establishment is much higher than allowed, since the maximum value allowed for an exposure of 8 hours per day is 85 dBA. This is due to the fact that equipment routinely used in this work environment presents an excessive noise level, either by the characteristics of the machinery or by the methods executed to perform a certain production task. Damage caused by exposure to noise, in this case, may become irreversible, since the time exposed in relation to the observed level are highly detrimental to the workers.

capacity, determined by hearing loss and the time it takes to return to initial conditions; The second classified as deafness, which depends on the characteristics of the noise that the individual is exposed, the time subject to exposure and individual susceptibility. This effect can affect not only the hearing aid, but also negatively influence communication, concentration, and danger alerts, as well as decreasing the performance of the worker. Therefore, in addition to the use of PPE, there is a necessity to adopt more rigorous measures, such as distancing or enclosing machines and equipment.

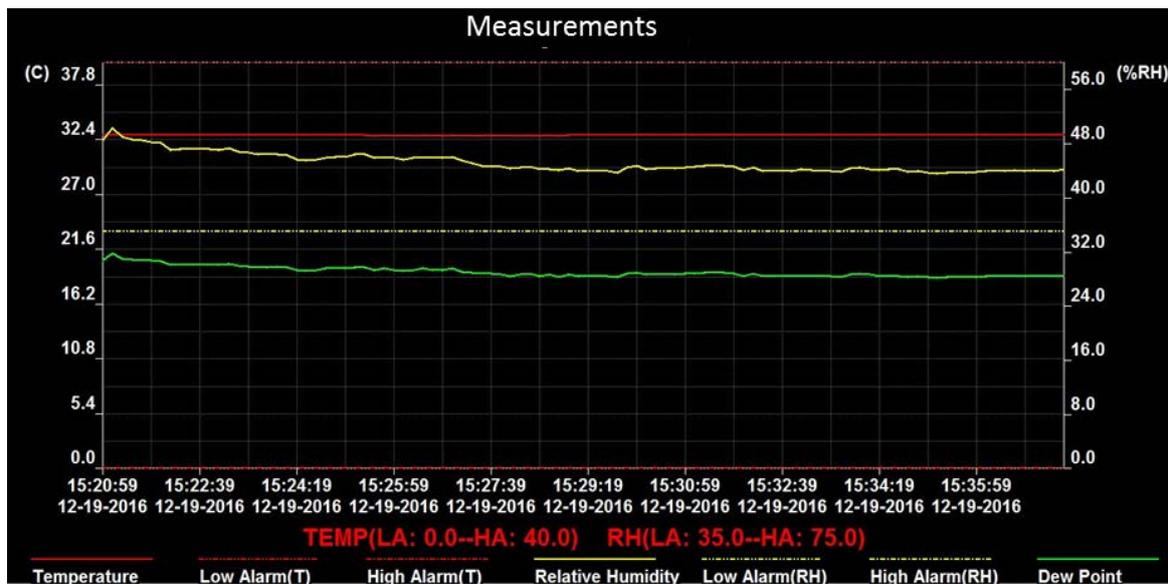
Figure 3: Graphs for pressure and temperature variations

According to Figure 3, the environment temperature that the establishment presented was approximately 32.4°C, which according to NR 17 is not appropriate for the activities developed, since the maximum allowed would be 23°C. These temperature values come from the location of this work environment that is located in the northeast region of the country, where in the time of measurements it was facing a drought and, on top of that, the temperature throughout its region was above average. As a measure of combat, it would be necessary to implement a cooling system, since the norm defines an ideal temperature lower than that submitted by the workers, however this strategy would be improper due to the characteristics of the activity in question, thus becoming a difficult factor to be fixed. Relative humidity, on the other hand, presented values that were in agreement, since according to the

graph the average value is approximately 44% and the minimum value allowed is 40%.

Also in relation to the high temperature detected in the studied environment, in addition to not having a cooling system, other methodologies couldn't be identified in order to alleviate this problem, such as exhaust fans and coolers. In this case, it is noticeable that the thermal comfort of the working environment is still merely being taken into account.

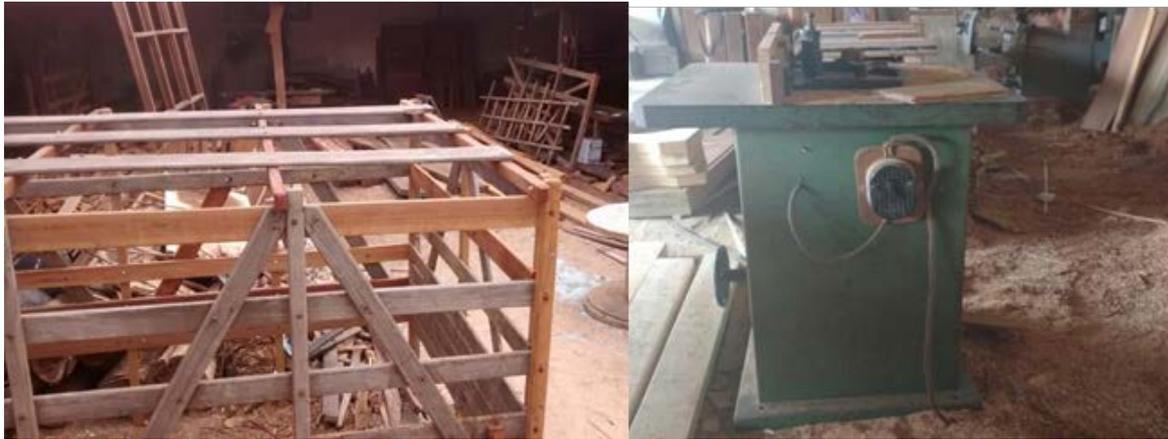
Figure 4 – Workplace

Based on Figure 4, there is a severe disorder in relation to the accommodation of the wood, as well as the accumulation of dust coming from the activities performed. These factors, in addition to providing an increase in accidents, may generate the occurrence of more risks, which can be environmental, ergonomic or accident hazards.

Thus, the best measures to be take would be the disposal of solid wastes, as well as the adequate accommodation of the wood. Another aspect that can be improved is the distribution of equipment within the environment.
